**Flood Control Project Maintenance
Levee Inspections****LMA District Cover Sheet****Spring 2013 Levee Inspection Results****Reclamation District No. 0554 Walnut Grove**

Spring 2013 Levee Inspection Results

Reclamation District No. 0554 Walnut Grove

Levee Inspection Report By Mile - Spring 2013

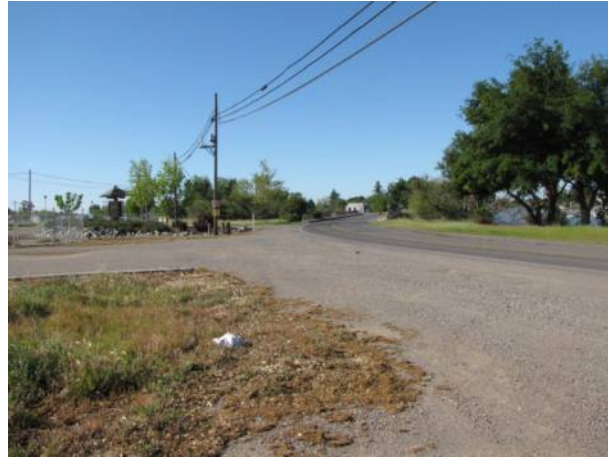
Levee Mile Report Line	4
Start Levee Mile	0.00
End Levee Mile	0.00
Location	Land Side
Category	
Item	Vegetation
RD 554 Looking downstream from levee mile 0.00 landside. Photo taken 4-10-2013.	
phillips_s_20130410_372.JPG

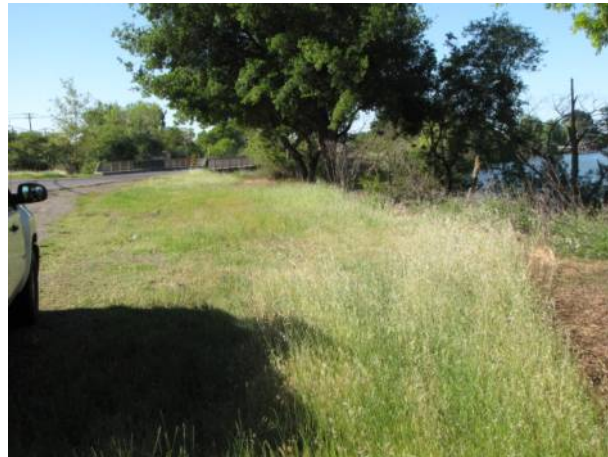
Levee Mile Report Line	5
Start Levee Mile	0.00
End Levee Mile	0.00
Location	Water Side
Category	
Item	Vegetation
RD 554 Standing on waterward shoulder looking down stream from levee mile 0.00. Photo taken 4-10-2013.	
phillips_s_20130410_373.JPG

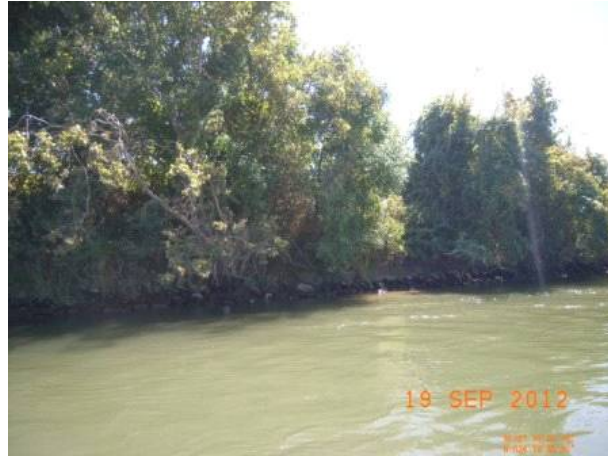
USACE 2012 Photo #2

Levee Mile Report Line	8
Start Levee Mile	0.25
End Levee Mile	0.34
Location	Water Side
Category	Supplemental
Item	USACE Erosion Survey

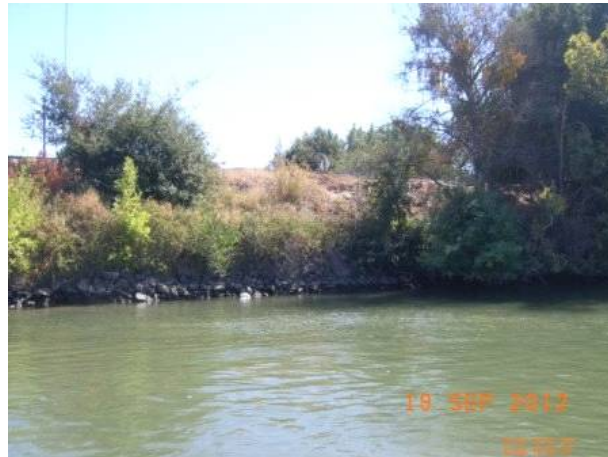
USACE 2012 Photo #3

Levee Mile Report Line	8
Start Levee Mile	0.25
End Levee Mile	0.34
Location	Water Side
Category	Supplemental
Item	USACE Erosion Survey
